# Microstructural Effects on Creep-Fatigue Life of Alloy 709

August 2017

**Idaho National Laboratory  
INL ART TDO Program  
Idaho Falls, Idaho 83415**

INL/EXT-17-41079  
Revision 0

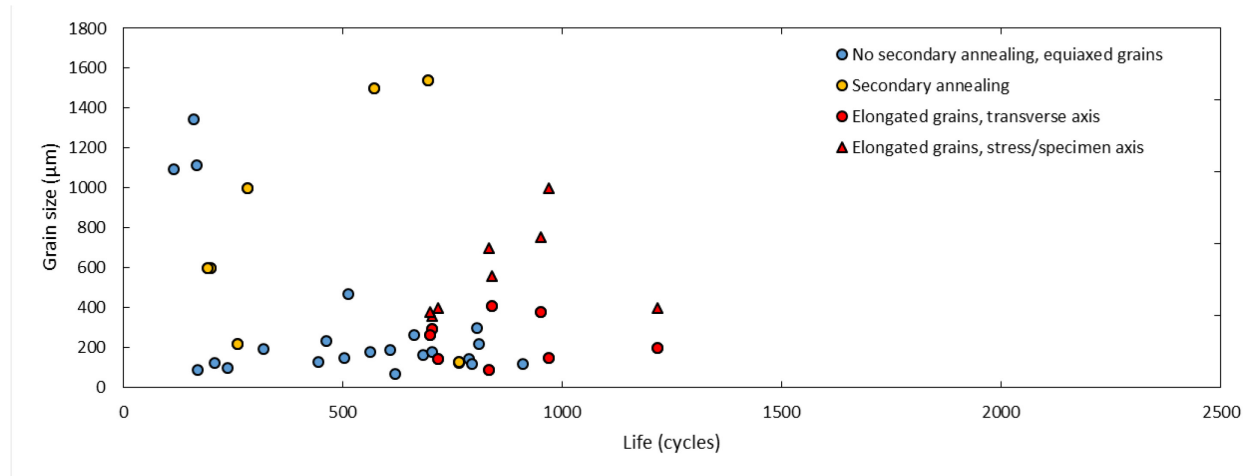
Figure 16. A more detailed breakdown of Figure 9, showing the size effect of the larger grains on creep-fatigue life. Specimens that underwent additional annealing are depicted separately, and the diameters both transverse and parallel to the stress axis are shown for specimens with elongated grains.

Elongated grains (narrow in the axis transverse to the stress axis) did not degrade the creep-fatigue resistance as dramatically as equiaxed large grains presumably because of the manner in which the creep-fatigue testing was conducted. The orientation of the specimen axis relative to the elongated grain diameters ( $\sim 300 \times 500 \mu\text{m}$  in the transverse  $\times$  tensile axes) in 39A11-A and 39A11-B likely had a role in the longer creep-fatigue cycles to failure than specimens with large equiaxed grains. The elongated grains in Figure 2 have an aspect ratio of over three with the longer dimensions along the specimen axis. The propagating surface cracks travel perpendicular to the stress/specimen axis and thus travel along smaller continuous grain boundary lengths. Figure 16 shows grain measurements in both the specimen axis (elongated) and the transverse axis (short). The specimens with grains elongated along the specimen axis exhibits unusually high fatigue lives for the grain sizes (red triangles in Figure 16); however, the transverse grain measurements (red circles in Figure 16) fall right in line with expected grain size vs. life based on equiaxed grain measurements. This further highlights that the length of the grain along the stress/specimen axis plays little to no role in the creep-fatigue life. The creep-fatigue resistance of longitudinally oriented specimens from plates 39A11, 39X11, 40A11 and 40X11 does not appear to be degraded and is similar to that of specimens with smaller, equiaxed grains (data recorded in Table 1 and Figure 9). The  $N_f$  range from over 600 to nearly 1000. Additional detail is available in previous reports.<sup>1,2</sup>
